BOA Architecture / Government Services
Rancho Palos Verdes ADA Assessment

Facility Report with Photos - Programs Services

Facility ID: # 02B - City Hall Buildings

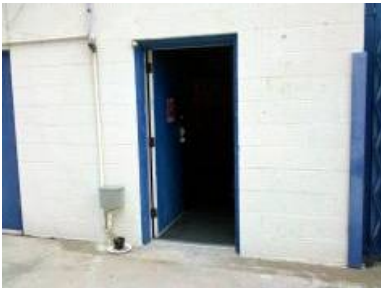
Keynote 1

10.02 - Entrance Sign - Accessible entrance is not identified by an ISA.

404 - Entrance Sign - Provide compliant entrance sign with ISA.

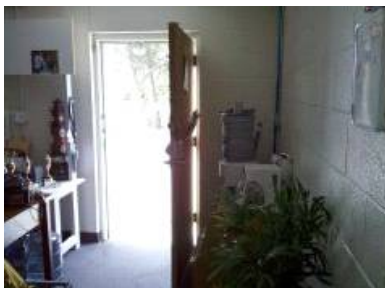
Keynote 2

10.06A - Door Maneuvering Space - Door that is not automatic or power-assisted does not have compliant maneuvering space relative to the direction of approach as shown in CBC Fig. 11B-26. (Approach // Side // Width // Depth) (Front // Pull // D + 24" * // 60") (Front // Push // D + 0" ** // 48") (Latch // Pull // D + 24" // 60") (Latch // Push // D + 24" // 44" ***) (Hinge // Pull // D + 36" // 60") (Hinge // Push // 54" **** // 44" *****) (* D + 18" at interior doors.) (** D + 12" if door has both a latch and a closer.) (***) 48" if door has closer.) (**** Measured from latch toward hinge.) (***** 48" if door has both a latch and a closer.)

Existing Condition: 4" non-fixed desk, pull side.

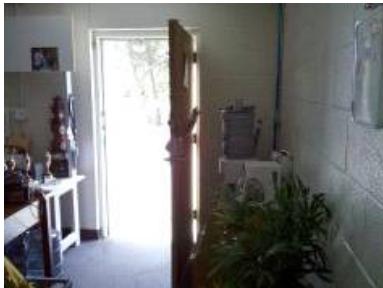
Keynote 7

Existing Condition: Door jamb at 77 3/4" AFF.

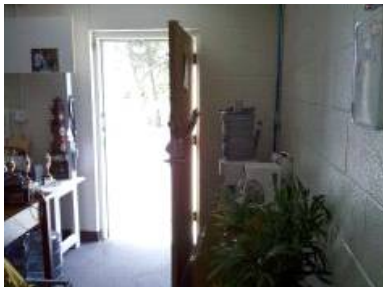
Keynote 8

Existing Condition: Coat hook at 72" AFF.

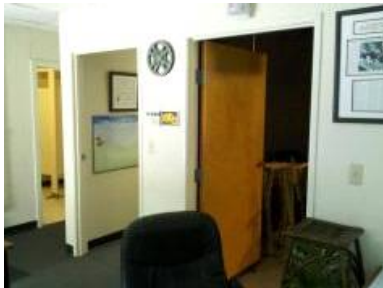
Keynote 9

Existing Condition: Security alarm at 57 1/4" AFF.

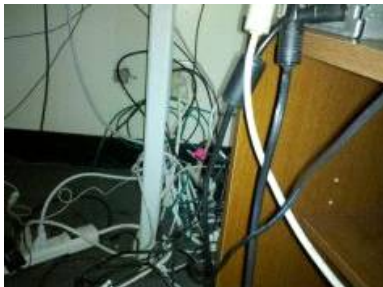
Keynote 10

Existing Condition: 3 power outlets and 1 data port at 12" AFF.

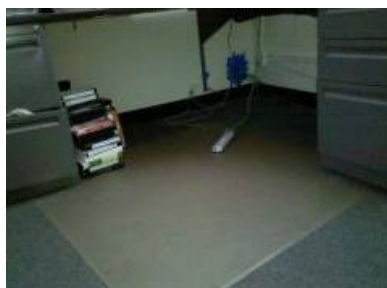
Keynote 13

Existing Condition: Mat.

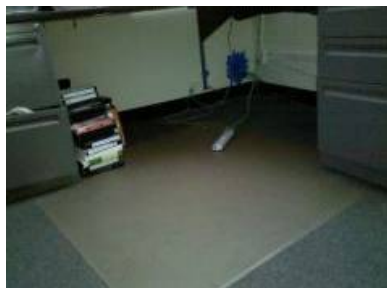
Keynote 14

Existing Condition: 3 power outlets and 1 data port at 11" AFF.

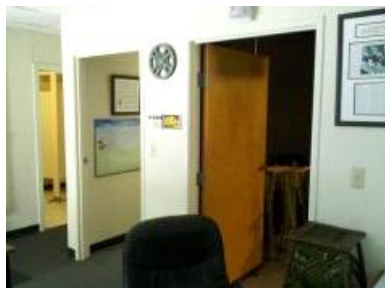
Keynote 16

Existing Condition: Door knob.

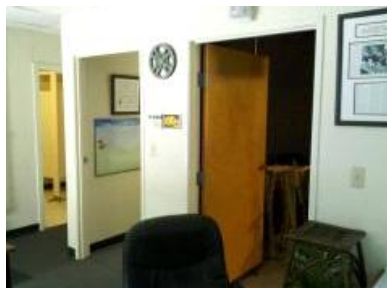
Keynote 17

11.17A - Recommendation: Providing Room/Space ID Sign - A sign designating the permanent room or space has not been provided.

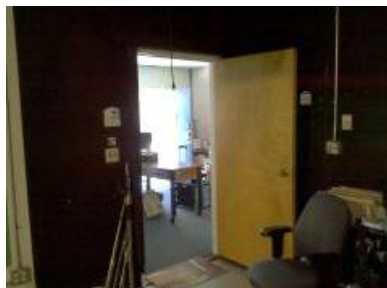
Keynote 18

Existing Condition: 5/8" change in level.

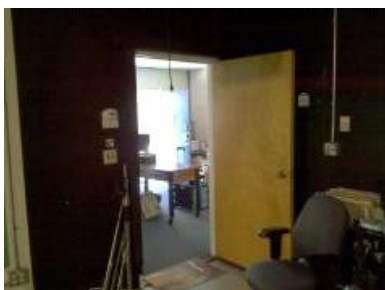
Keynote 19

Existing Condition: Door jamb at 79 1/2" AFF.

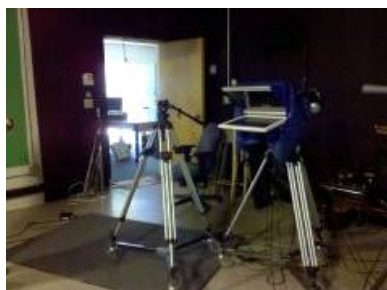
Keynote 21

Existing Condition: Floor mat.

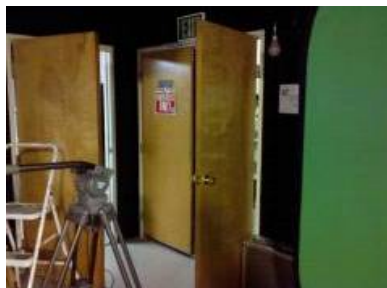
Keynote 22

Existing Condition: 27 1/2" clear opening.

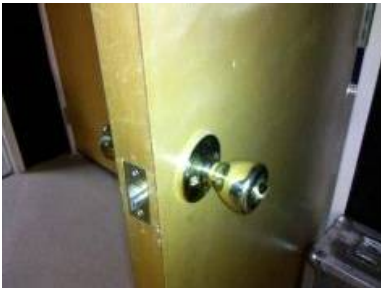
Keynote 23

11.11 - Single-Action Hardware - Handles, locks, and latches or other operative devices are not operable with one hand and without tight grasping, pinching, or twisting of the wrist. (U-shaped handles, levers, and push/pull type mechanisms are acceptable designs.)

Existing Condition: Door knob.

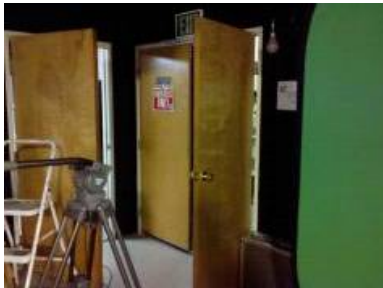
Keynote 24

11.21A - Required Exit Route Sign - At exit access door from an interior room or area that is required to have a visual exit sign, there is no tactile and CA Braille exit sign with the words "EXIT ROUTE" mounted on the wall adjacent to the latch side of the door. (Visual exit signs are required when two or more exits are required. Generally, all occupants shall have access to two exits from a floor (CBC Table 1019.1). Exceptions: a) Single story building with maximum occupant load of 49 and less than 75 ft travel distance to exit (CBC Table 1019.2), and b) Two story building with maximum occupant load of 30 occupants per floor and maximum travel distance of 75 ft to exit. (CBC Table 1019.2). Two exit access doors are required from an office tenant space when the occupant load exceeds 49.)

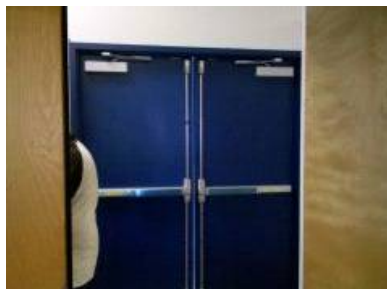
Keynote 28

10.08 - Kick Plate - Bottom 10" of door does not have a smooth, uninterrupted surface on the push side to allow the door to be opened by a wheelchair footrest without creating a trap or hazardous condition. (This requirement does not apply to automatic and sliding doors.)

Existing Condition: Panic rods obstruct kick plate area.

Additional Comments: Replace doors with internal locking mechanism doors.

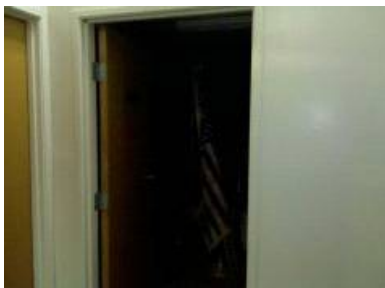
Keynote 30

14.31 - Head Room - Clear head room is at less than 80" within the pedestrian circulation area, including the accessible route of travel.

Existing Condition: Door jamb at 79 7/8" AFF.

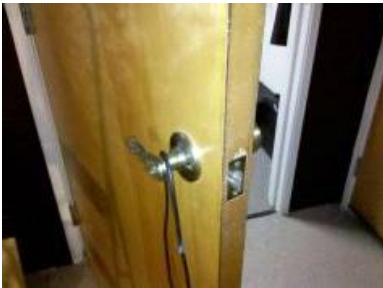
Keynote 31

11.11 - Single-Action Hardware - Handles, locks, and latches or other operative devices are not operable with one hand and without tight grasping, pinching, or twisting of the wrist. (U-shaped handles, levers, and push/pull type mechanisms are acceptable designs.)

Existing Condition: Door knob & twist-type locking mechanism.

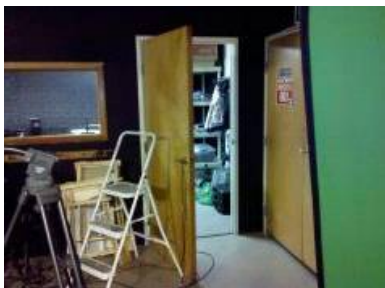
Keynote 32

11.06A - Door Maneuvering Space - Door that is not automatic or power-assisted does not have compliant maneuvering space relative to the direction of approach as shown in CBC Fig. 11B-26. (Approach // Side // Width // Depth) (Front // Pull // D + 24" * // 60") (Front // Push // D + 0" ** // 48") (Latch // Pull // D + 24" // 60") (Latch // Push // D + 24" // 44" ***) (Hinge // Pull // D + 36" // 60") (Hinge // Push // 54" **** // 44" *****) (* D + 18" at interior doors.) (** D + 12" if door has both a latch and a closer.) (***) 48" if door has closer.) (**** Measured from latch toward hinge.) (***** 48" if door has both a latch and a closer.)

Existing Condition: 12 1/2" pull side.

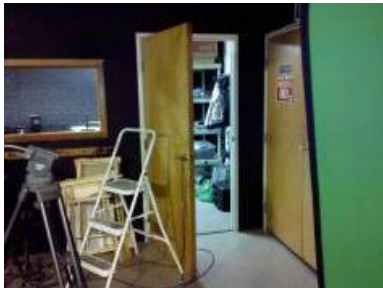
Keynote 33

Existing Condition: Door jamb at 79 1/4" AFF.

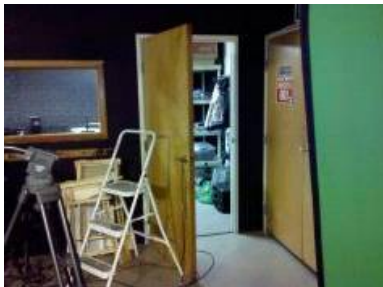
Keynote 34

11.17A - Recommendation: Providing Room/Space ID Sign - A sign designating the permanent room or space has not been provided.

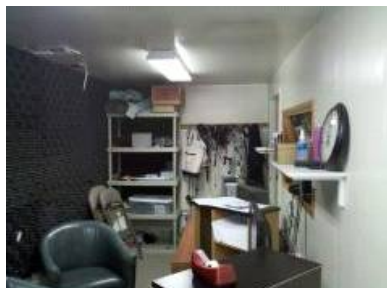
Keynote 36

Existing Condition: 24" clearance due to non-fixed furniture.

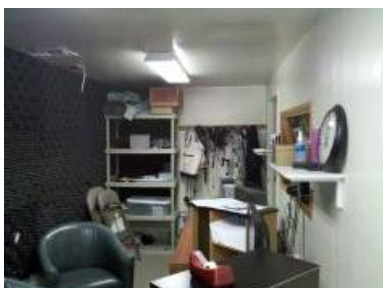
Keynote 37

Existing Condition: 2 shelves at 57" AFF.

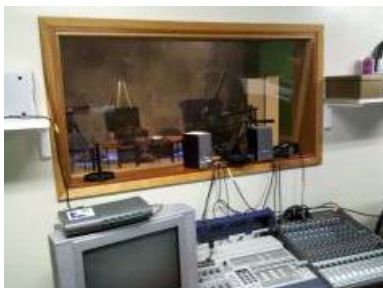
Keynote 38

Existing Condition: Observation window sill at 46 1/2" AFF.

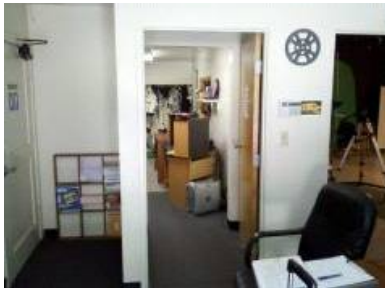
Keynote 39

Existing Condition: 1 3/4" pull side & 43" landing at pull side.

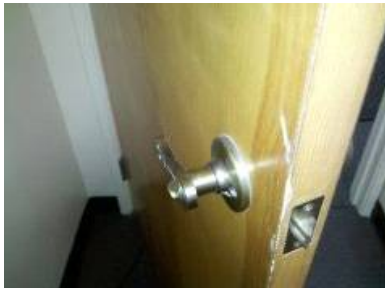
Keynote 40

Existing Condition: Door knob & twist-type locking mechanism.

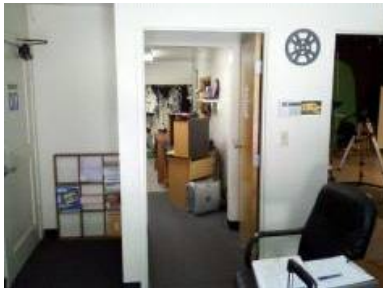
Keynote 42

Existing Condition: Coat hook at 63" AFF.

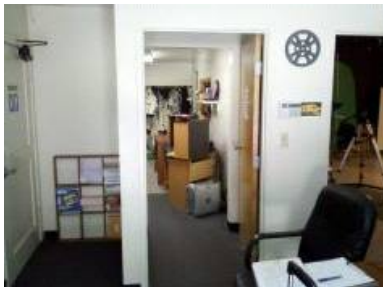
Keynote 43

Existing Condition: Door jamb at 79 3/4" AFF.

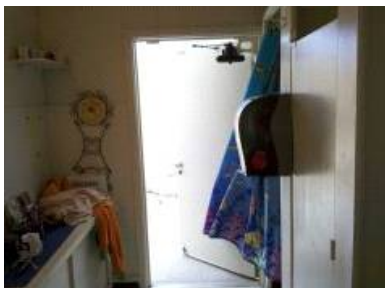
44

16.09A - Door Maneuvering Space - Door that is not automatic or power-assisted does not have compliant maneuvering space relative to the direction of approach as shown in CBC Fig. 11B-26. (Approach // Side // Width // Depth) (Front // Pull // D + 24" * // 60") (Front // Push // D + 0" ** // 48") (Latch // Pull // D + 24" // 60") (Latch // Push // D + 24" // 44" ***) (Hinge // Pull // D + 36" // 60") (Hinge // Push // 54" **** // 44" *****) (* D + 18" at interior doors.) (** D + 12" if door has both a latch and a closer.) (***) 48" if door has closer.) (**** Measured from latch toward hinge.) (***** 48" if door has both a latch and a closer.)

Existing Condition: 9" to counter at pull side.

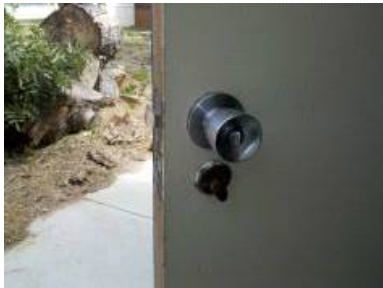
Keynote 45

16.10 - Single-Action Hardware - Handles, locks, and latches or other operative devices are not operable with one hand. OR They are not operable without tight grasping, pinching, or twisting of the wrist. (U-shaped handles, levers, and push/pull type mechanisms are acceptable designs.)

Existing Condition: Door knob & twist-type locking mechanisms.

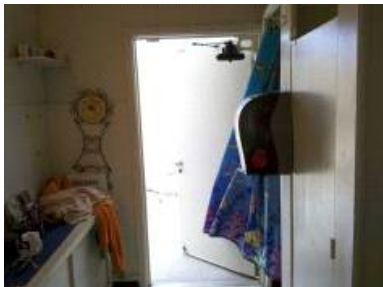
Keynote 46

16.11A - Door Operating Effort - The force required to operate door exceeds 5 lbs. (Fire doors may have up to 15 lbs to achieve positive latching).

Existing Condition: 22 LBF.

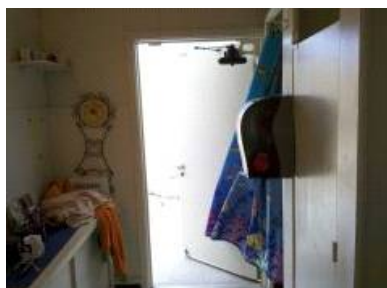
Keynote 47

Existing Condition: Door jamb at 77" AFF & Closer at 71" AFF.

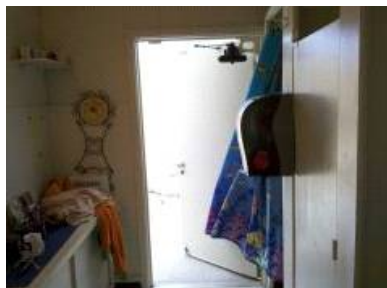
Keynote 51

Existing Condition: 42" diameter circle provided.

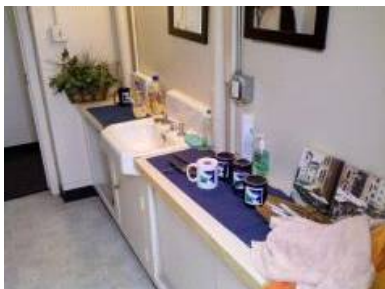
Keynote 56

16.82A - Mirror Height - Max. 40" AFF Standard - Mirror above accessible lavatory or countertop is mounted so the bottom edge of the reflective surface is not 40" max.. AFF. (ADA Standards require at least one mirror to be accessible; CBC Standards prior to August 1, 2009 required all mirrors to be accessible. Effective August 1, 2009, amended CBC Standards require all mirrors above accessible lavatories or countertops to be accessible.)

Existing Condition: 51 1/2" AFF.

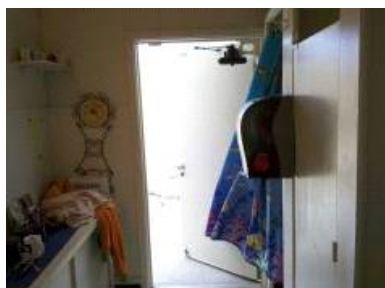
Keynote 57

16.84A - Paper Towel Dispenser - Operating Height - Mounting height of paper towel dispenser's highest operable part exceeds 40" AFF. (Where provided, ADA Standards require at least one paper towel dispenser to be accessible with the highest operable part placed within at least one of the reach ranges specified in 4.2.5 and 4.2.6; where provided, CBC Standards require at least one paper towel dispenser to be accessible with the highest operable part no higher than 40" AFF.)

Existing Condition: 45" AFF.

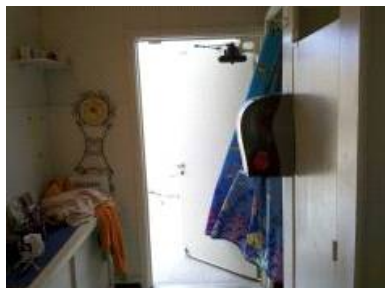
Keynote 58

14.30A - Wall-Mounted Protruding Objects - Wall-mounted object(s) with leading edges between 27 and 80" from the floor project more than 4" into the pathway. (Wall mounted objects with leading edges at or below 27" may project any amount as long as the required clear width of an accessible route is not reduced.)

Existing Condition: PTD protrudes 10" at 45" AFF.

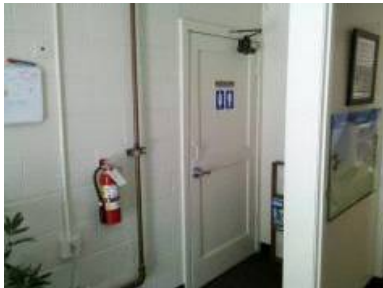
Keynote 61

16.09A - Door Maneuvering Space - Door that is not automatic or power-assisted does not have compliant maneuvering space relative to the direction of approach as shown in CBC Fig. 11B-26. (Approach // Side // Width // Depth) (Front // Pull // D + 24" * // 60") (Front // Push // D + 0" ** // 48") (Latch // Pull // D + 24" // 60") (Latch // Push // D + 24" // 44" ***) (Hinge // Pull // D + 36" // 60") (Hinge // Push // 54" **** // 44" *****) (* D + 18" at interior doors.) (** D + 12" if door has both a latch and a closer.) (***) 48" if door has closer.) (**** Measured from latch toward hinge.) (***** 48" if door has both a latch and a closer.)

Existing Condition: 35 1/2" landing at latch approach, pull side.

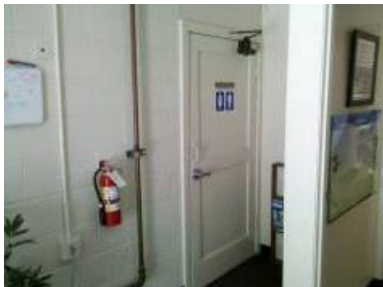
Keynote 63

Existing Condition: Door cannot open 90 degrees.

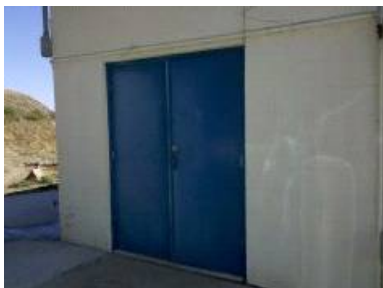
Keynote 68

Existing Condition: 28" clear opening.

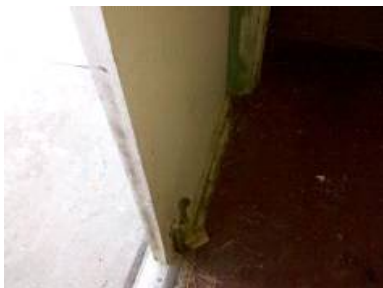
Keynote 69

10.08 - Kick Plate - Bottom 10" of door does not have a smooth, uninterrupted surface on the push side to allow the door to be opened by a wheelchair footrest without creating a trap or hazardous condition. (This requirement does not apply to automatic and sliding doors.)

Existing Condition: Door stops and latch at kick plate area.

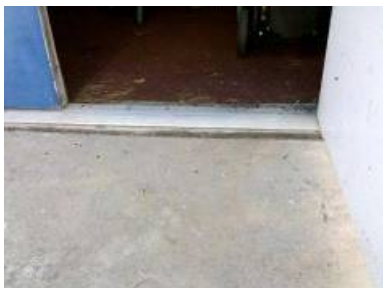
Keynote 70

Existing Condition: 1" change in level.

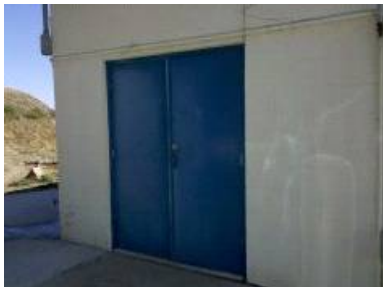
Keynote 71

Existing Condition: Door jamb at 78 1/2" AFF.

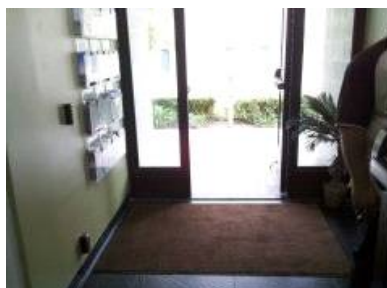
Keynote 72

Existing Condition: Unsecured floor mat.

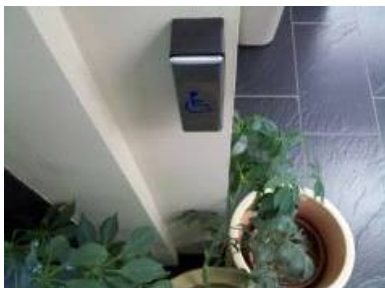
Keynote 74

Existing Condition: Motorized door actuator not functioning.

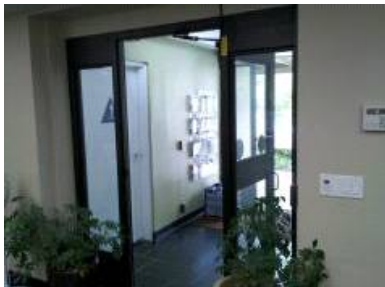
Keynote 75

Existing Condition: 6 LBF.

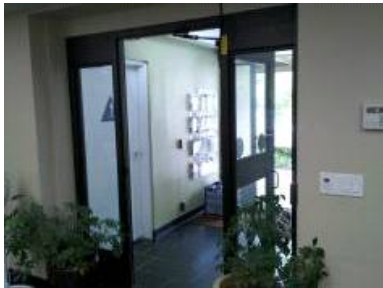
Keynote 76

Existing Condition: 15 LBF.

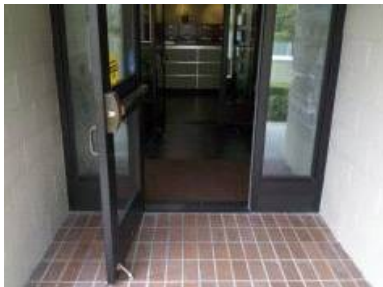
Keynote 77

10.08 - Kick Plate - Bottom 10" of door does not have a smooth, uninterrupted surface on the push side to allow the door to be opened by a wheelchair footrest without creating a trap or hazardous condition. (This requirement does not apply to automatic and sliding doors.)

Existing Condition: Door stop.

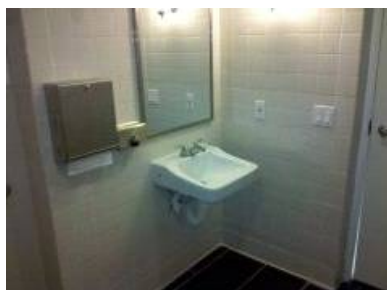
Keynote 78

Existing Condition: Door swing encroaches lavatory clear floor space.

053 - Reverse Door Swing - Remove existing door and frame and replace with new frame. Reinstall existing door (reverse door swing). Provide new accessible door hardware.

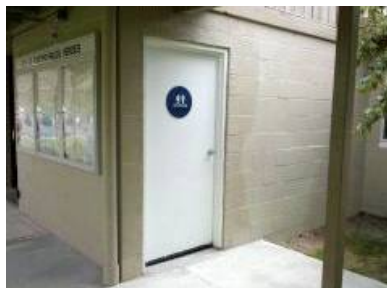
Keynote 79

Existing Condition: 11 LBF.

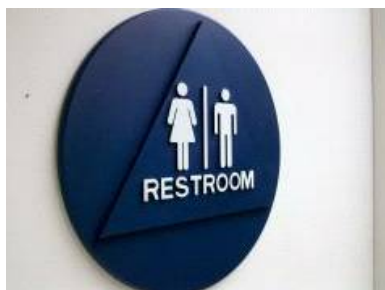
Keynote 80

Existing Condition: Braille on door sign.

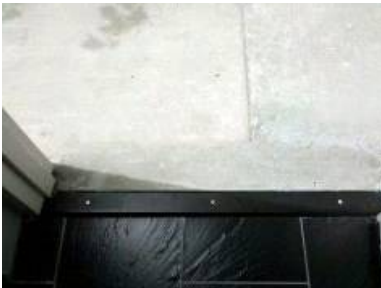
Keynote 84

Existing Condition: Threshold.

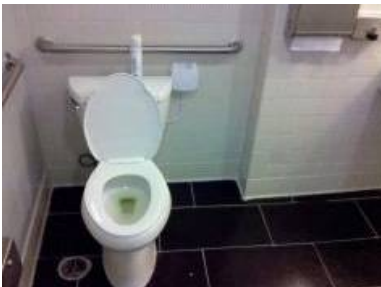
Keynote 85

Existing Condition: 17 1/4" clear.

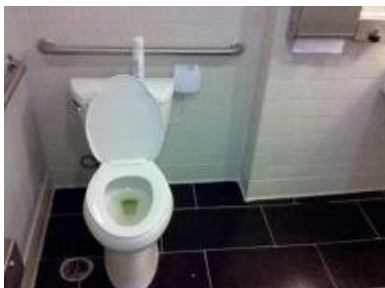
Keynote 86

Existing Condition: Not on wide side.

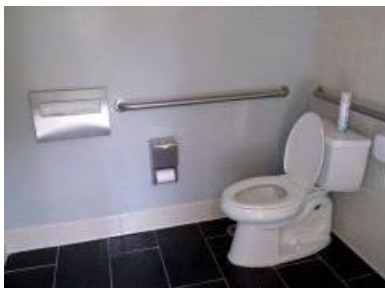
Keynote 87

Existing Condition: 44 1/2" from back wall.

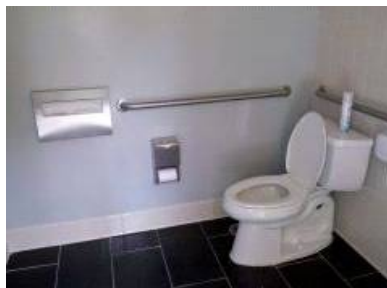
Keynote 88

Existing Condition: 35" AFF.

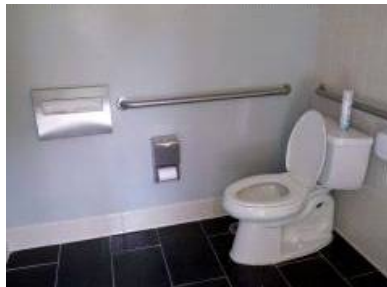
Keynote 89

Existing Condition: 1 5/8" clear.

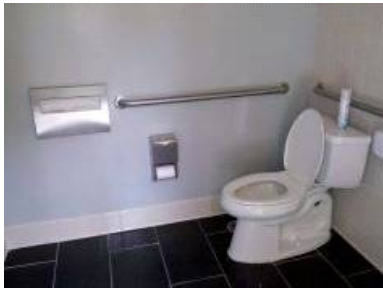
Keynote 90

Existing Condition: 50 1/2".

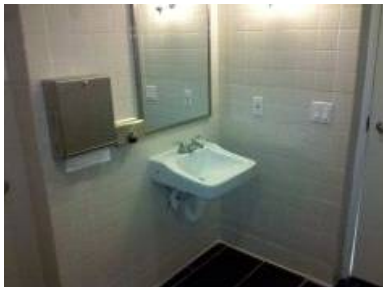
Keynote 91

Existing Condition: 28 1/2" clear.

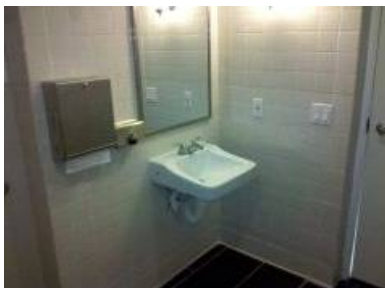
Keynote 92

16.73 - Lavatory Knee Clearance - Lavatory does not provide accessible knee clearance (i.e. at least 27" clearance from the floor to the underside of the lavatory, extending 8" min.. measured from the front edge underneath the lavatory back towards the wall).

Existing Condition: 26 1/4" clear.

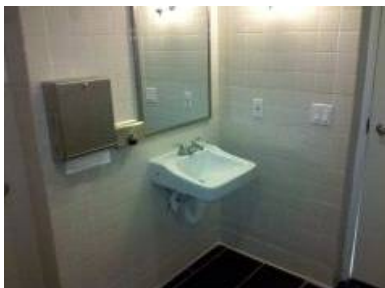
Keynote 93

16.76 - Lavatory - Clearance near Sidewall - The centerline of the lavatory is not 18" min.. from the nearest sidewall or partition.

Existing Condition: 16" from side wall.

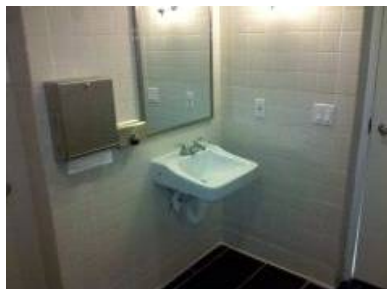
Keynote 95

Existing Condition: 40 1/2" AFF.

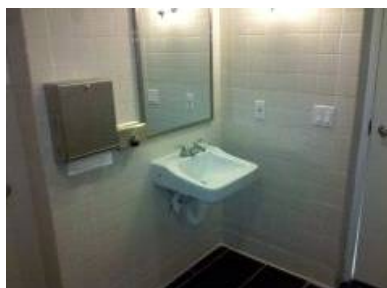
Keynote 96

Existing Condition: 40 1/2" AFF.

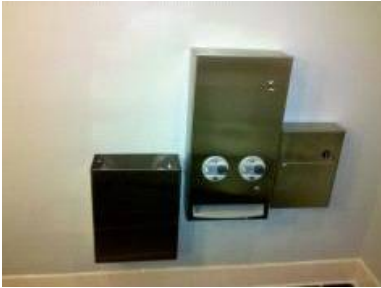
Keynote 98

16.84D - Sanitary Napkin/Feminine Hygiene Dispenser - Operating Height - Mounting height of sanitary napkin/feminine hygiene dispenser's highest operable part exceeds 40" AFF. (Where provided, ADA Standards require at least one sanitary napkin/feminine hygiene dispenser to be accessible with the highest operable part placed within at least one of the reach ranges specified in 4.2.5 and 4.2.6; where provided, CBC Standards require at least one sanitary napkin/feminine hygiene dispenser to be accessible with the highest operable part no higher than 40" AFF.)

Existing Condition: 46" AFF.

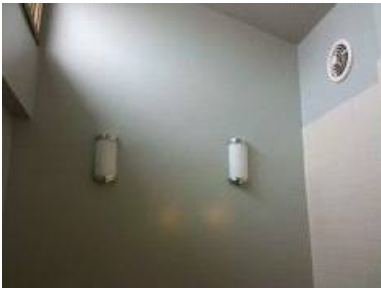
Keynote 99

20.02 - Toilet, Bathroom, or Shower Room - Visual Alarms - Visual alarms are not provided at public or common use toilet, bathroom, or shower room.

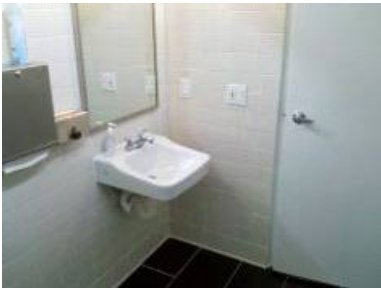
Keynote 100

16.09A - Door Maneuvering Space - Door that is not automatic or power-assisted does not have compliant maneuvering space relative to the direction of approach as shown in CBC Fig. 11B-26. (Approach // Side // Width // Depth) (Front // Pull // D + 24" * // 60") (Front // Push // D + 0" ** // 48") (Latch // Pull // D + 24" // 60") (Latch // Push // D + 24" // 44" ***) (Hinge // Pull // D + 36" // 60") (Hinge // Push // 54" **** // 44" *****) (* D + 18" at interior doors.) (** D + 12" if door has both a latch and a closer.) (***) 48" if door has closer.) (**** Measured from latch toward hinge.) (***** 48" if door has both a latch and a closer.)

Existing Condition: 13" pull side, lavatory.

053 - Reverse Door Swing - Remove existing door and frame and replace with new frame. Reinstall existing door (reverse door swing). Provide new accessible door hardware.

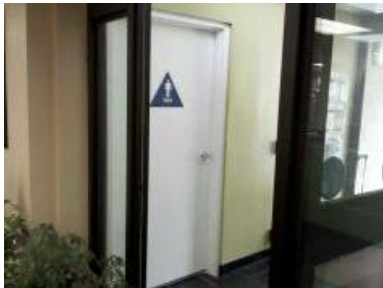
Keynote 101

16.11A - Door Operating Effort - The force required to operate door exceeds 5 lbs. (Fire doors may have up to 15 lbs to achieve positive latching).

Existing Condition: 7 LBF.

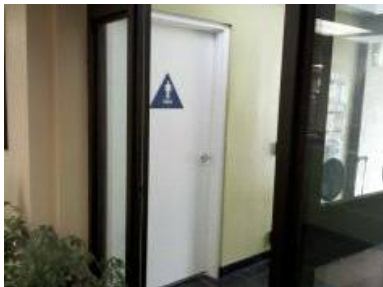
Keynote 102

16.13A - Men's RR Geometric Symbol Signage - Triangle - Doorway leading to a men's toilet room is not identified by an equilateral triangle 1/4" thick with edges 12" long. OR Equilateral triangle is provided, however it is accompanied by words in raised characters and Braille. (ADA and CBC Standards require a separate sign with raised characters and Braille mounted on the wall adjacent to the latch side of the door.)

Existing Condition: Braille on sign.

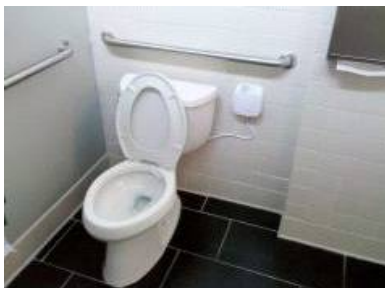
Keynote 107

Existing Condition: 18 1/2" from side wall.

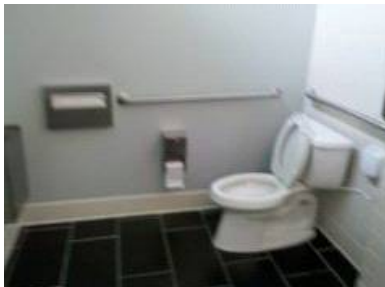
Keynote 108

Existing Condition: 41" from back wall.

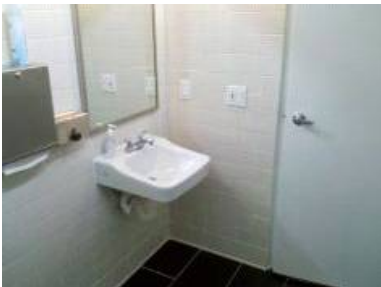
Keynote 114

Existing Condition: 25 1/2" clear.

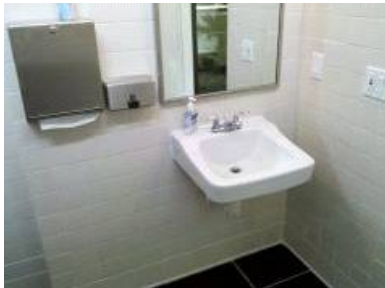
Keynote 119

Existing Condition: 40 1/2" AFF.

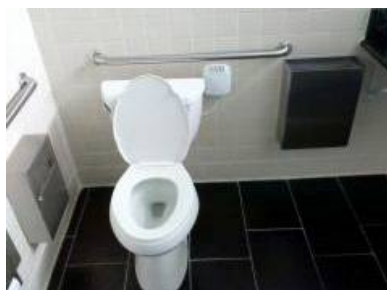
Keynote 128

Existing Condition: 16" to waste bin.

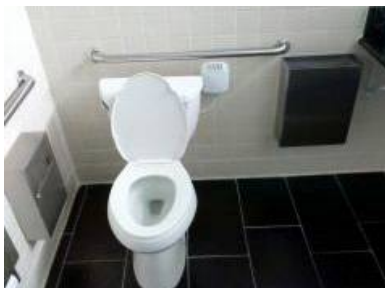
Keynote 129

16.47A - WC Location from Sidewall - The centerline of the WC is not 18" absolute from a wall or partition.

Existing Condition: 21" from side wall.

319C - Water Closet - New Location - Replace existing water closet with compliant model in new location.

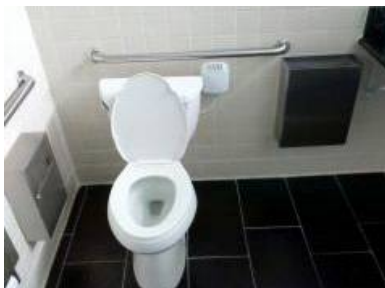
Keynote 130

16.49B - WC Flush Controls - Location - Flush controls are not located on the wide side of the WC where the clear floor space is provided.

Existing Condition: Not on wide side.

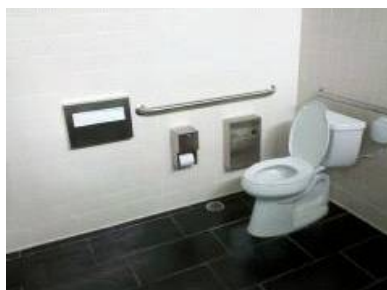
Keynote 131

Existing Condition: 44" from back wall.

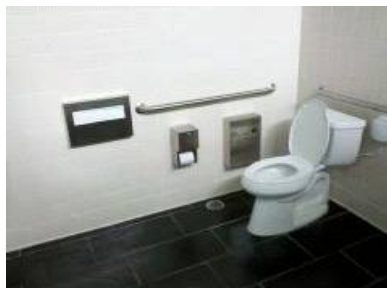
Keynote 132

Existing Condition: 1 5/8" clear.

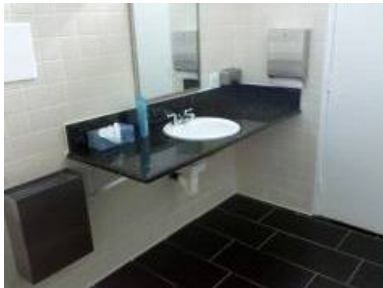
Keynote 135

16.82A - Mirror Height - Max. 40" AFF Standard - Mirror above accessible lavatory or countertop is mounted so the bottom edge of the reflective surface is not 40" max.. AFF. (ADA Standards require at least one mirror to be accessible; CBC Standards prior to August 1, 2009 required all mirrors to be accessible. Effective August 1, 2009, amended CBC Standards require all mirrors above accessible lavatories or countertops to be accessible.)

Existing Condition: 42" AFF.

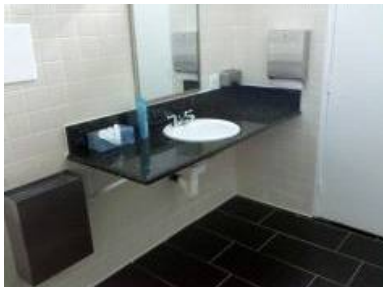
Keynote 136

16.84C - Soap Dispenser - Operating Height - Mounting height of soap dispenser's highest operable part exceeds 40" AFF. (Where provided, ADA Standards require at least one soap dispenser to be accessible with the highest operable part placed within at least one of the reach ranges specified in 4.2.5 and 4.2.6; where provided, CBC Standards require at least one soap dispenser to be accessible with the highest operable part no higher than 40" AFF.)

Existing Condition: 41 3/8" AFF.

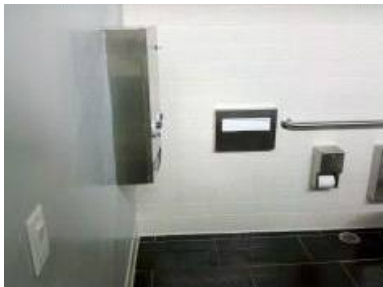
Keynote 138

14.30A - Wall-Mounted Protruding Objects - Wall-mounted object(s) with leading edges between 27 and 80" from the floor project more than 4" into the pathway. (Wall mounted objects with leading edges at or below 27" may project any amount as long as the required clear width of an accessible route is not reduced.)

Existing Condition: Feminine napkin dispenser protrudes 6 3/4" at 29 3/4" AFF.

292 - Relocate Sanitary Napkin/ Feminine Hygiene Dispenser - Women's Restroom - Relocate existing sanitary napkin/feminine hygiene dispenser so height of operating handles is no higher than 40" above finish floor. Patch and repair wall substrate and finishes, to match adjacent undisturbed surfaces.

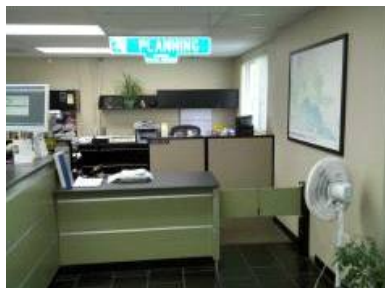
Keynote 139

Existing Condition: 4 1/2" knee depth.

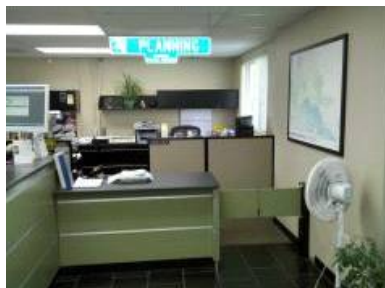
Keynote 140

Existing Condition: Bottom of swing gate is 16 1/4" AFF.

Additional Comments: Replace swing gate.

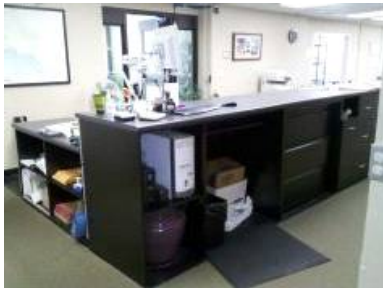
Keynote 141

Existing Condition: 3/4" knee depth at employee side.

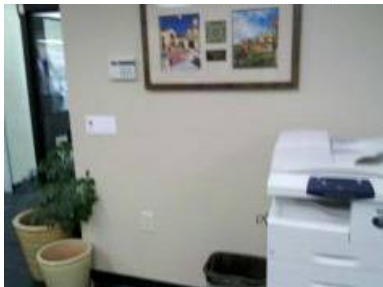
Keynote 142

Existing Condition: Security pad at 59 1/2" AFF.

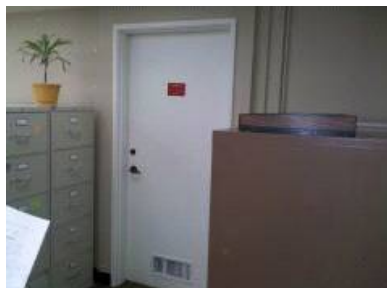
Keynote 144

11.15A - Kick Plate - Bottom 10" of door does not have a smooth, uninterrupted surface on the push side to allow the door to be opened by a wheelchair footrest without creating a trap or hazardous condition. (This requirement does not apply to automatic and sliding doors.)

Existing Condition: Bottom of vent grill at 2 1/2" AFF.

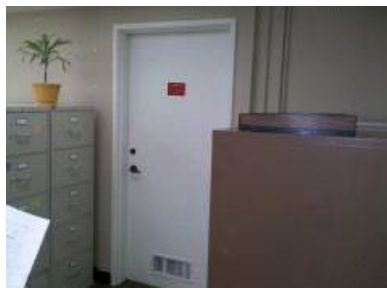
Keynote 145

Existing Condition: Lock at 45 1/2" AFF.

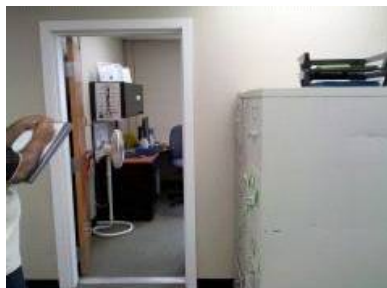
Keynote 146

Existing Condition: Door jamb at 76 3/4" AFF.

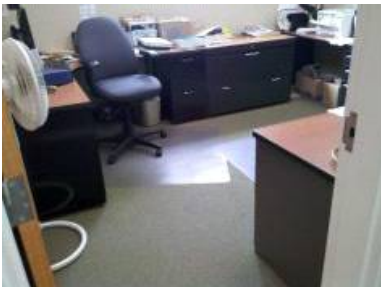
Keynote 148

Existing Condition: Floor mats.

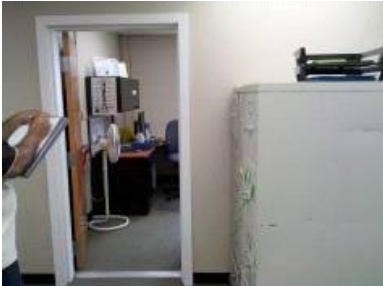
Keynote 149

11.10B - Threshold - Height - The threshold at doorway exceeds 1/2" in height.

Existing Condition: 3/4" change in level.

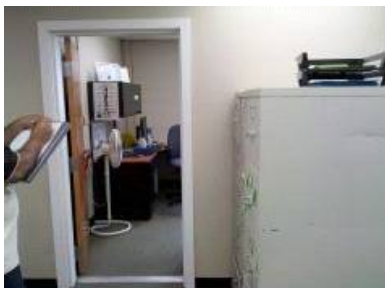
Keynote 151

11.17A - Recommendation: Providing Room/Space ID Sign - A sign designating the permanent room or space has not been provided.

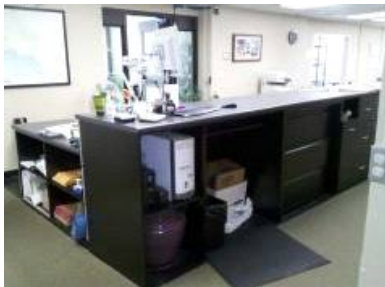
Keynote 152

Existing Condition: 41 3/4" to top of counter at computer stations.

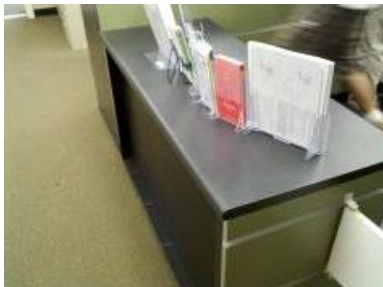
Keynote 154

Existing Condition: 1/2" knee depth at employee side.

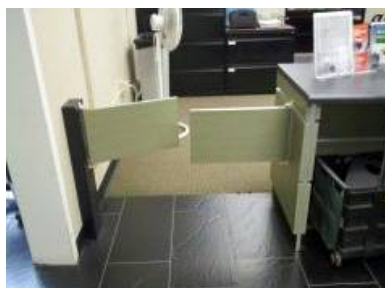
Keynote 157

11.04 - Gates - Gate does not comply with all applicable ADAAG and CBC accessibility requirements for doors. (ADAAG and CBC accessibility requirements for doors apply to gates, including ticket gates.)

Existing Condition: Bottom of swing gate at 16 1/4" AFF.

Additional Comments: Replace swing gate.

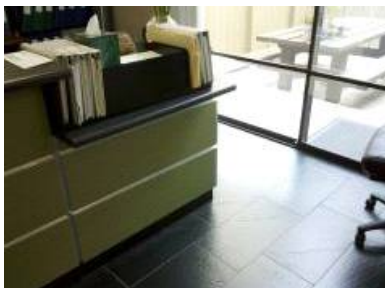
Keynote 159

12B.11C - Counter - Knee Space Depth - Where seating for persons in wheelchairs is provided at table or counter, knee space is not at least 19" deep.

Existing Condition: 6 1/2" knee depth.

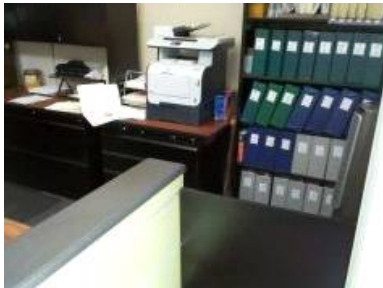
Keynote 160

11.06A - Door Maneuvering Space - Door that is not automatic or power-assisted does not have compliant maneuvering space relative to the direction of approach as shown in CBC Fig. 11B-26. (Approach // Side // Width // Depth) (Front // Pull // D + 24" * // 60") (Front // Push // D + 0" ** // 48") (Latch // Pull // D + 24" // 60") (Latch // Push // D + 24" // 44" ***) (Hinge // Pull // D + 36" // 60") (Hinge // Push // 54" **** // 44" *****) (* D + 18" at interior doors.) (** D + 12" if door has both a latch and a closer.) (***) 48" if door has both a latch and a closer.) (**** Measured from latch toward hinge.)

Existing Condition: Non-fixed furniture encroaches swing gate landing.

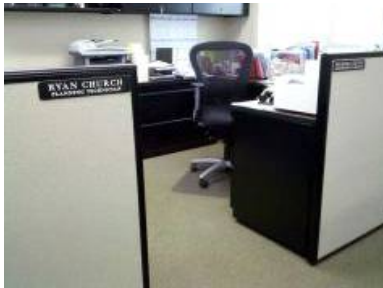
Location: Photo #
Comm. Dev. - Open Office 163

Existing Condition: Floor mat.

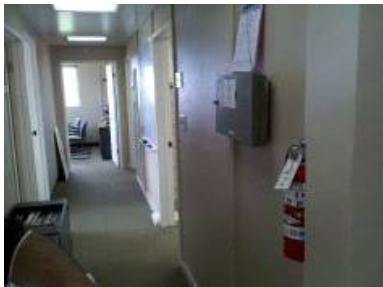
Location: Photo #
Comm. Dev. - Hallway 164

Existing Condition: Key lockbox at 58" AFF.

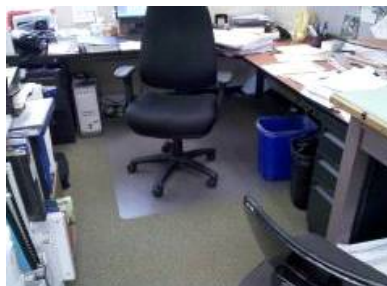
Location: Comm. Dev. - Office
Photo # 168

Existing Condition: Floor mat.

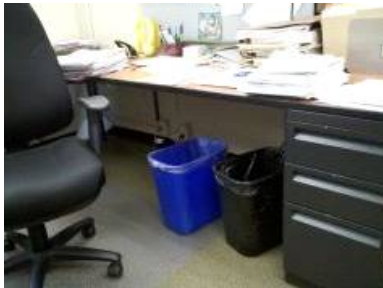
Photo #
170

Existing Condition: Power outlets at less than 15" AFF.

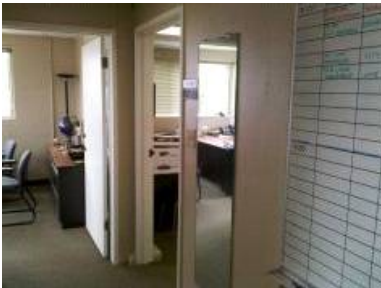
Keynote 172

Existing Condition: Door jamb at 79 3/4" AFF.

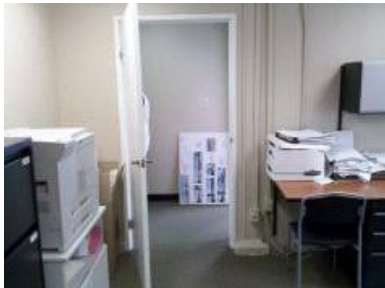
Keynote 174

Existing Condition: Coat hook at 67" AFF.

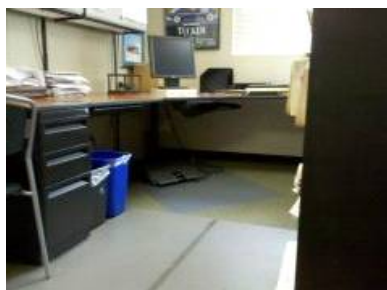
Photo #
176

Existing Condition: Floor mat.

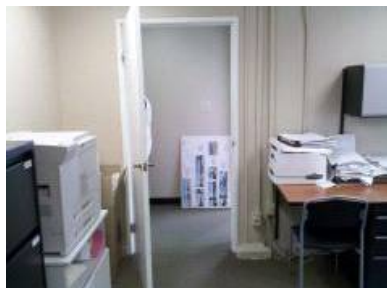
Keynote 177

Existing Condition: 4 power outlets and 1 data port between 12" & 14" AFF.

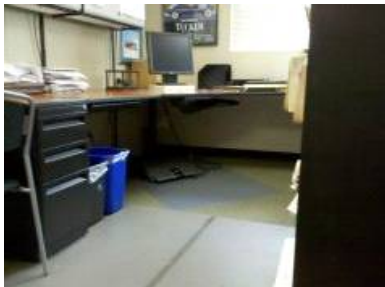
Keynote 179

Existing Condition: Knee space at 26 3/4".

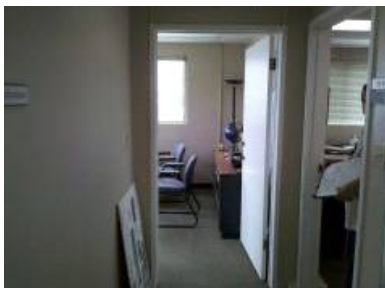
Photo #
180

11.17A - Recommendation: Providing Room/Space ID Sign - A sign designating the permanent room or space has not been provided.

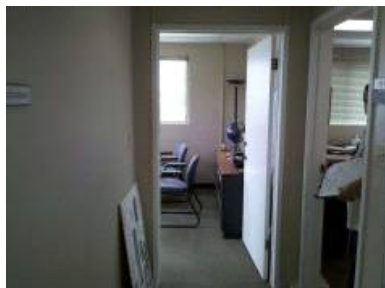
Keynote 181

11.06A - Door Maneuvering Space - Door that is not automatic or power-assisted does not have compliant maneuvering space relative to the direction of approach as shown in CBC Fig. 11B-26. (Approach // Side // Width // Depth) (Front // Pull // D + 24" * // 60") (Front // Push // D + 0" ** // 48") (Latch // Pull // D + 24" // 60") (Latch // Push // D + 24" // 44" ***) (Hinge // Pull // D + 36" // 60") (Hinge // Push // 54" **** // 44" *****) (* D + 18" at interior doors.) (** D + 12" if door has both a latch and a closer.) (*** 48" if door has closer.) (**** Measured from latch toward hinge.) (***** 48" if door has both a latch and a closer.)

Existing Condition: Non-fixed furniture encroaches pull side door landing.

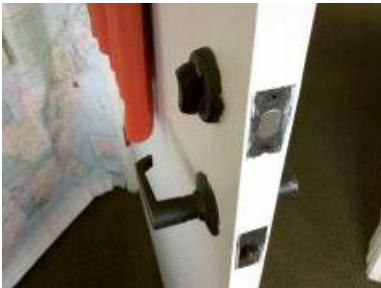
Photo #
182

Existing Condition: Twist-type lock.

031B - Replace Control - Replace control. Repair/refinish as required.

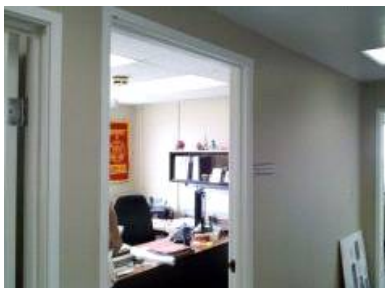
Photo #
185

11.17A - Recommendation: Providing Room/Space ID Sign - A sign designating the permanent room or space has not been provided.

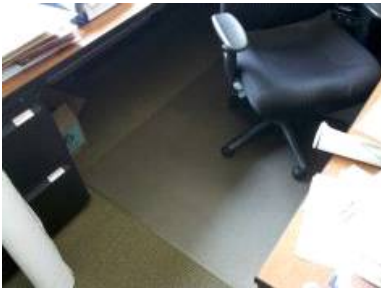
Keynote 187

14.23B - Floor Surface - Accessible route surfaces are not stable, firm and slip-resistant.

Existing Condition: Floor mat.

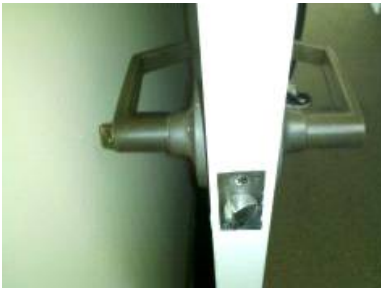
Keynote 191

11.11 - Single-Action Hardware - Handles, locks, and latches or other operative devices are not operable with one hand and without tight grasping, pinching, or twisting of the wrist. (U-shaped handles, levers, and push/pull type mechanisms are acceptable designs.)

Existing Condition: Twist-type lock.

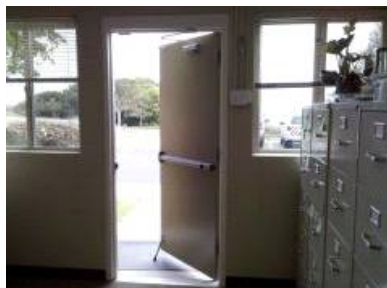
Keynote 196

Existing Condition: 7 LBF.

072B - Replace Closer - Replace door closer.

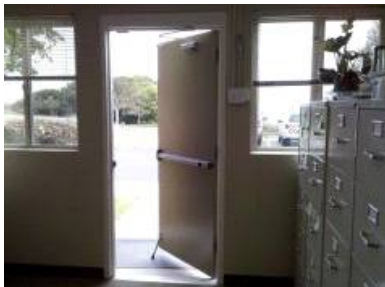
Keynote 198

Existing Condition: 11 LBF.

072D - Replace Hardware with Panic Device - Replace door hardware with panic device.

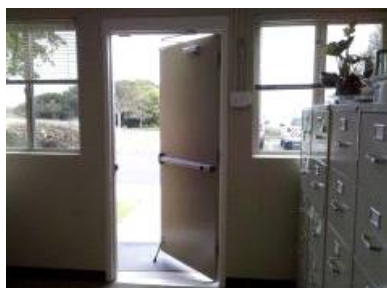
Keynote 199

10.08 - Kick Plate - Bottom 10" of door does not have a smooth, uninterrupted surface on the push side to allow the door to be opened by a wheelchair footrest without creating a trap or hazardous condition. (This requirement does not apply to automatic and sliding doors.)

Existing Condition: Door stop.

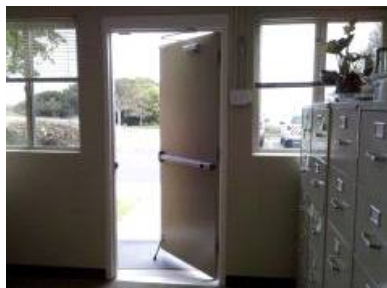
Keynote 201

Existing Condition: Light switch at 62" AFF.

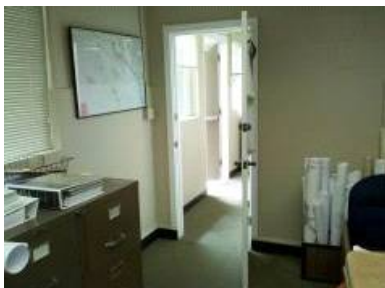
Photo #
203

Existing Condition: Door jamb at 76 3/4" AFF.

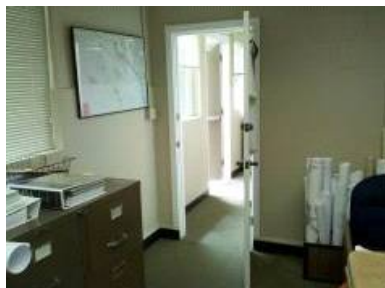
Keynote 205

11.05A - Clear Opening - Single-Leaf Door - When the door is open 90 degrees, clear opening width is not at least 32" measured between the face of the door and the doorstop on the latch side.

Existing Condition: 26" clear.

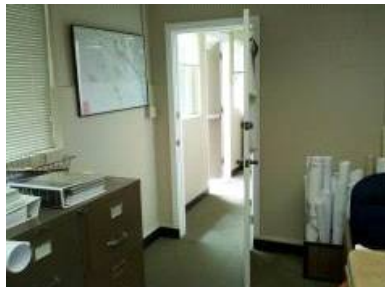
Keynote 206

11.15A - Kick Plate - Bottom 10" of door does not have a smooth, uninterrupted surface on the push side to allow the door to be opened by a wheelchair footrest without creating a trap or hazardous condition. (This requirement does not apply to automatic and sliding doors.)

Existing Condition: 8 1/2".

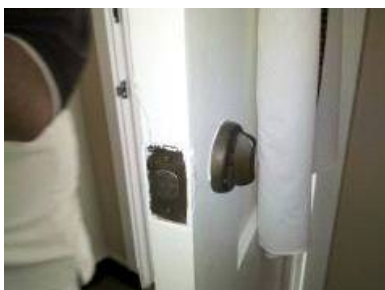
Photo #
207

Existing Condition: Twist-type lock.

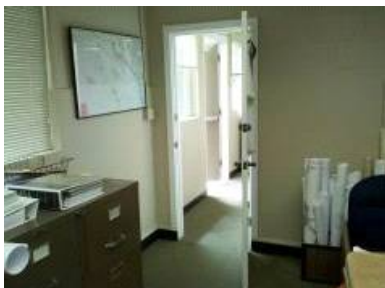
Photo #
203

Field Condition

Existing Condition: Twist-type lock at 48" AFF.

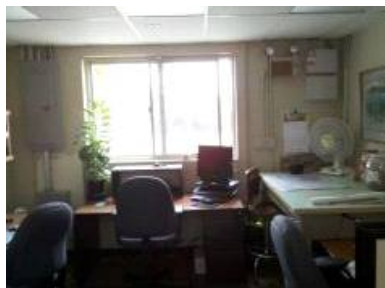
Location: Photo #
Comm. Dev. - Open Office 212

Field Condition

Existing Condition:

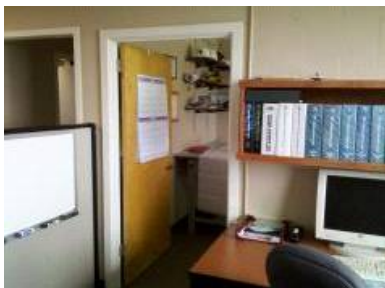
Photo #
213

Existing Condition: Door jamb at 77 1/4" AFF.

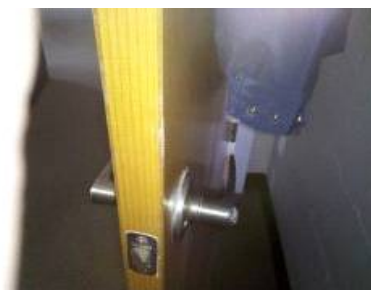
11.11 - Single-Action Hardware - Handles, locks, and latches or other operative devices are not operable with one hand and without tight grasping, pinching, or twisting of the wrist. (U-shaped handles, levers, and push/pull type mechanisms are acceptable designs.)

Existing Condition:

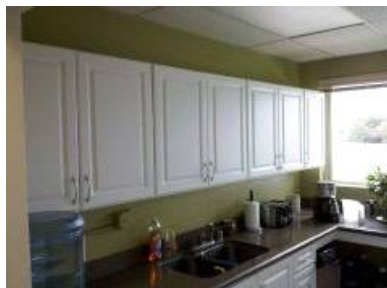
Location: Photo #
Comm. Dev. - Break Room 217

Field Condition

Existing Condition:

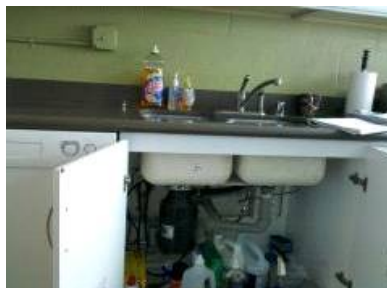
Location: Photo #
Comm. Dev. - Break Room 218

Field Condition

Existing Condition:

480A - New Counter Top and Sink - Remove existing cabinetry, and provide new counter at 34" above the finished floor. Remove and replace sink and faucet with new accessible sink and faucet. Provide accessible knee clearance (i.e. at least 27" high, 30" wide, and 19" deep) under the sink.

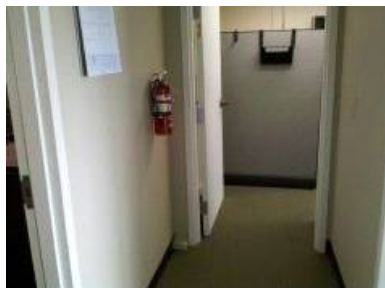
20.16B - Surface-Mounted Fire Extinguisher - Mounting Height - Where fire extinguishers are surface-mounted, mounting height of the extinguisher is not compliant. (Compliant surface-mounted extinguisher is 48" AFF maximum, as measured to the highest operable part, or in existing buildings, when the extinguisher is 54" AFF and parallel approach is provided)

Existing Condition: 52" AFF.

388D - Relocate Fire Extinguisher - Relocate existing fire extinguisher. Repair and refinish.

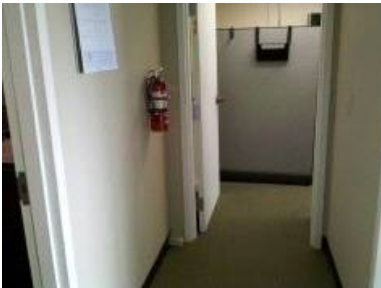
Photo #
220

Existing Condition: Fire extinguisher protrudes 4 3/4" at 39 1/4" AFF.

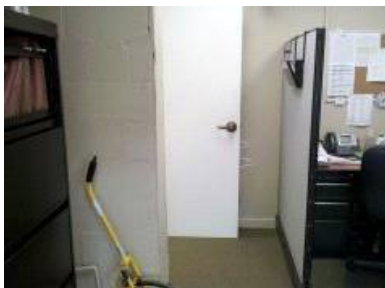
11.07A - Landing - Level and Clear - Floor is not level (slope is greater than 2% in some or all directions). OR Floor is not clear within the required maneuvering space.

Existing Condition: Non-fixed furniture encroaches door landing at pull side.

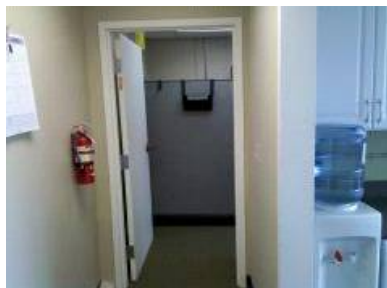
Photo #
225

Existing Condition: Door jamb at 79" AFF.

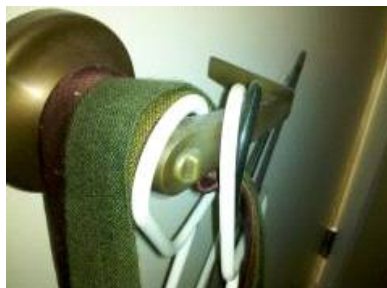
Photo #
226

Existing Condition: Twist-type lock.

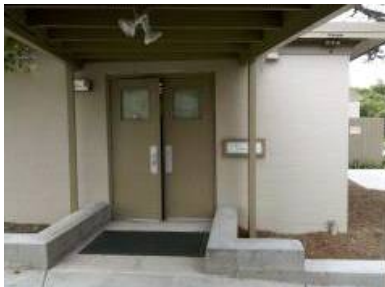
Photo #
230

Field Condition

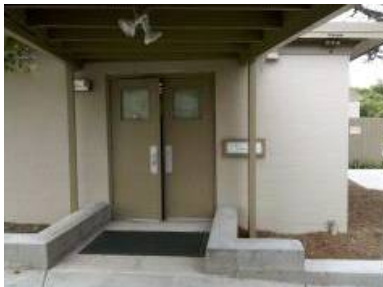
11.15B_04AG - Vision Lights - Door, gate, or adjacent sidelight, containing one or more vision lights, does not include at least one vision light mounted with the bottom edge of the glazed panel at 43" max.. AFF. (Exception: Vision lights with the lowest part more than 66" AFF.)

Existing Condition: 60" AFF.

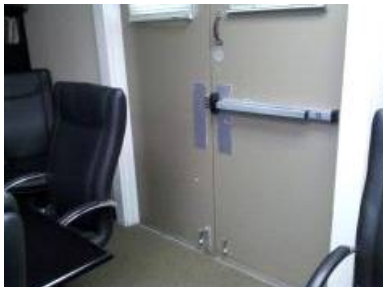
Location: Comm. Dev. - Conference Rm
Photo # 233

10.08 - Kick Plate - Bottom 10" of door does not have a smooth, uninterrupted surface on the push side to allow the door to be opened by a wheelchair footrest without creating a trap or hazardous condition. (This requirement does not apply to automatic and sliding doors.)

Existing Condition: Latch.

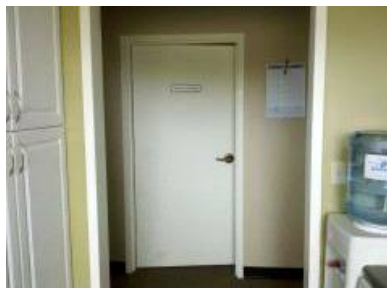
Photo #
238

11.17A - Recommendation: Providing Room/Space ID Sign - A sign designating the permanent room or space has not been provided.

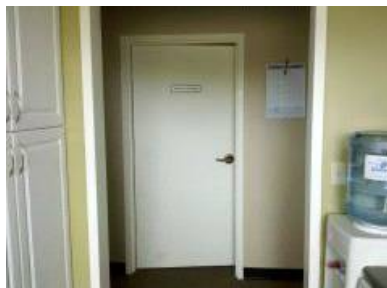
Photo #
238

Existing Condition: Door jamb at 79" AFF.

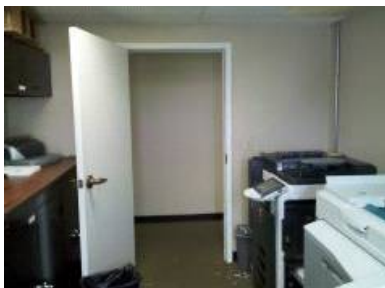
14.31 - Head Room - Clear head room is at less than 80" within the pedestrian circulation area, including the accessible route of travel.

Existing Condition: Door jamb at 79 1/8" AFF.

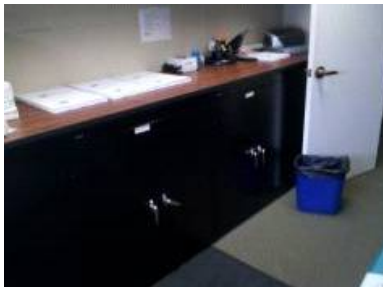
Photo #
246

Existing Condition: 42 1/2" to counter top, 0" knee space.

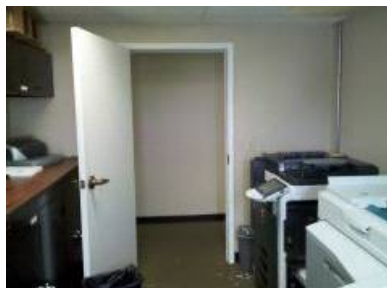
Photo #
243

Field Condition

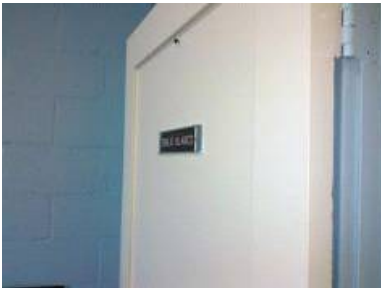
11.23A - Mounting Location (Visual/Tactile Signs) - Sign is not mounted on the wall adjacent to the latch side of the door. OR At double leaf doors, the sign is not placed on the nearest adjacent wall.

Existing Condition: Mounted on door

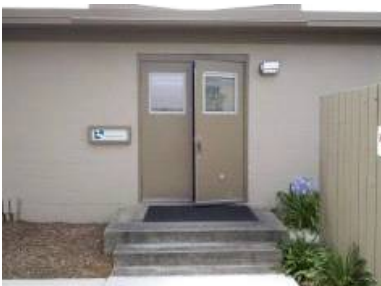
Location: Admin. - Office
Photo # 194

10.02 - Entrance Sign - Accessible entrance is not identified by an ISA.

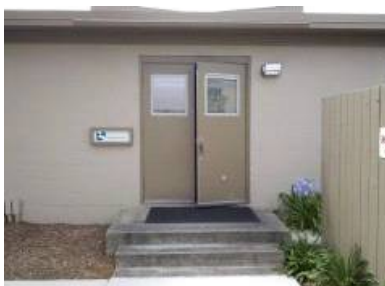
Photo #
250

Existing Condition: 28" clear.
